**STATE OF HAWAII
DEPARTMENT OF LAND AND NATURAL RESOURCES
ENGINEERING DIVISION
DAM SAFETY PROGRAM
Honolulu, Hawaii**

STAFF REPORT

Regarding: Dam Safety Enforcement Action on Wahiawa Dam (OA-0017) for Failure to Comply with Notice of Deficiency, Issued February 18, 2020

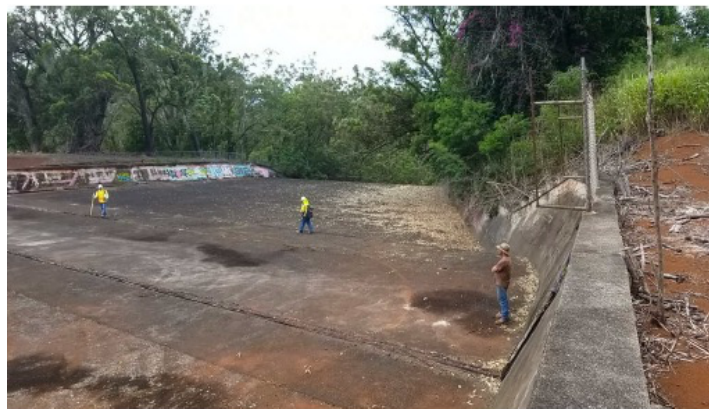
Figure 4. Spillway looking downstream.

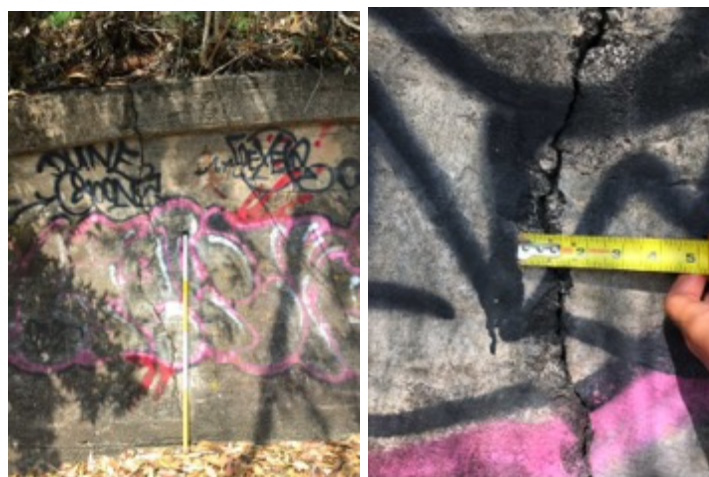
Figure 5. Crack in right spillway wall.
